October 9, 2012

RE: Report No. R-100812-01  
Structural Inspection  
Horse Riding Arena  
[REDACTED]  
Rolla, Missouri 65401

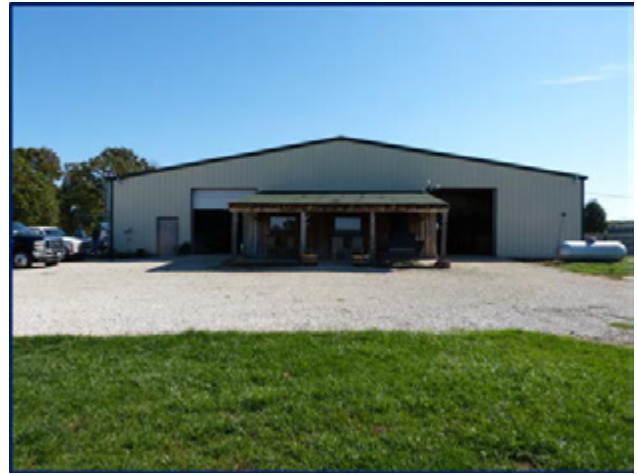
Dear Mr. [REDACTED],

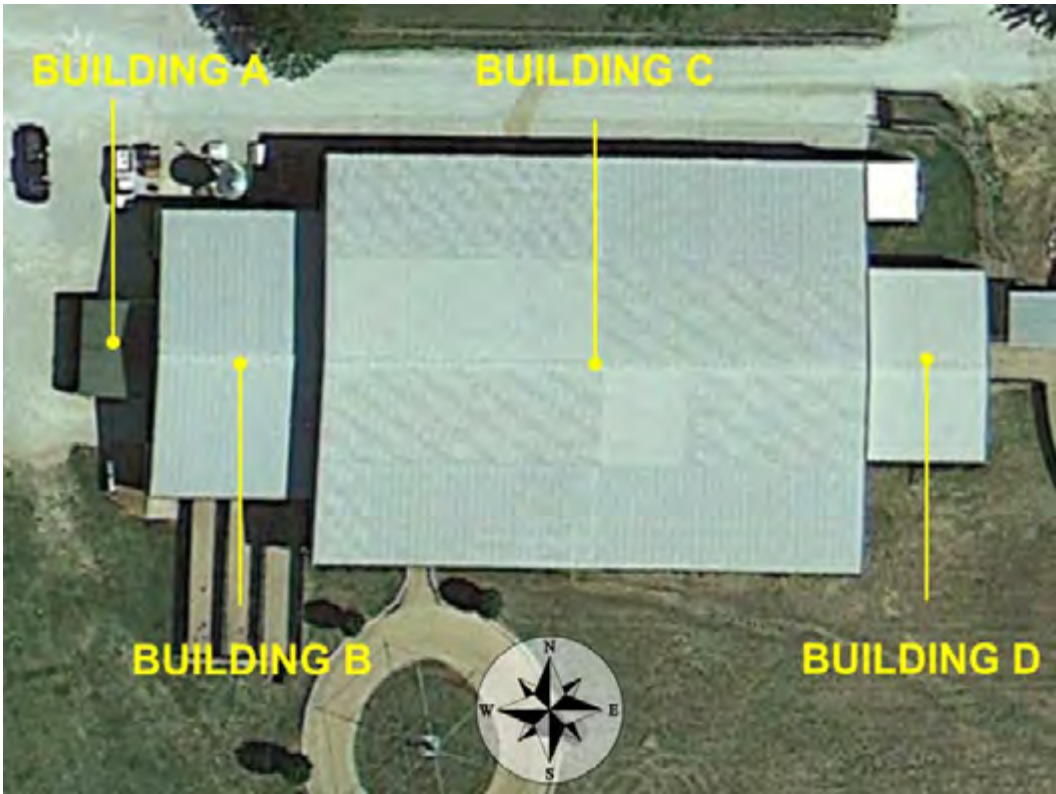
Figure 1 – Building reference and orientation

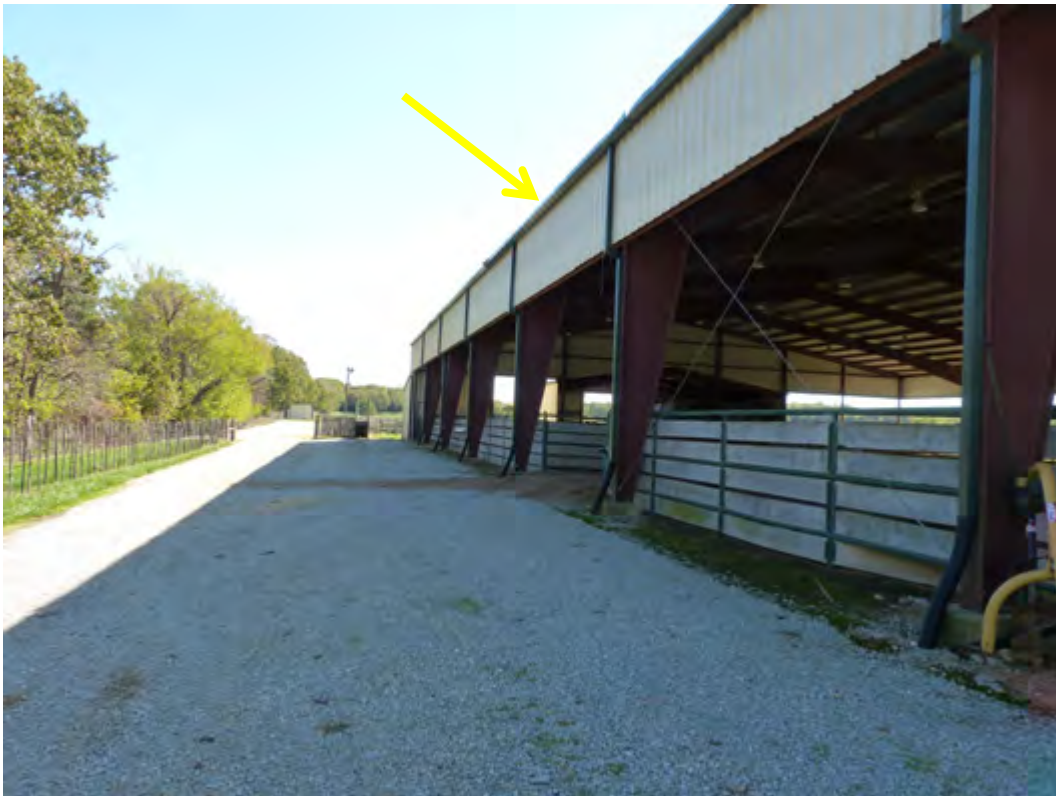
Figure 2 – Damaged gutter Building C, North side

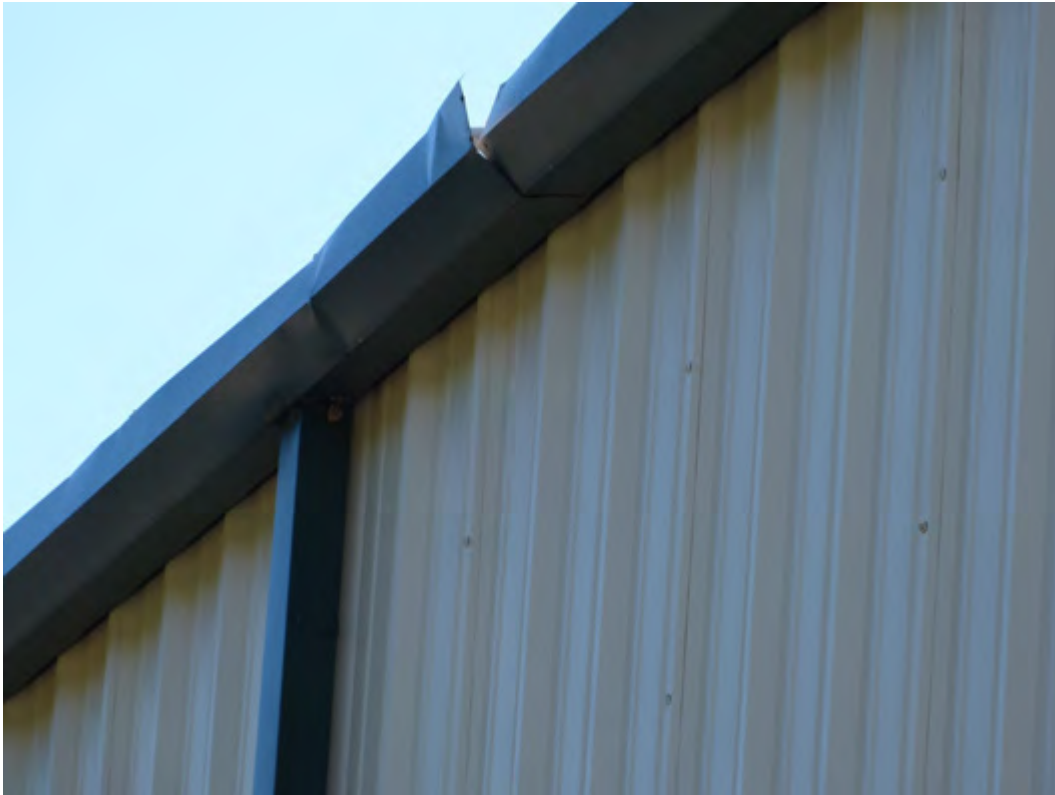
Figure 3 – Close-up view of damaged gutter in Figure 2

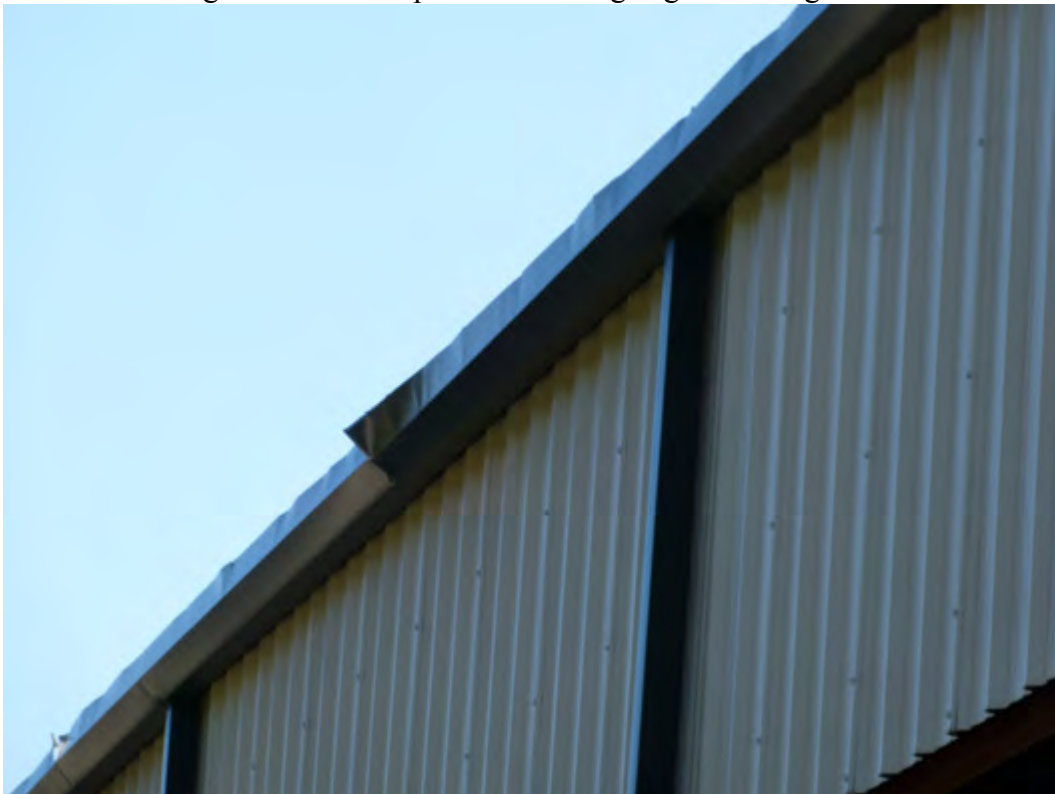
Figure 4 – Close-up view of damaged gutter in Figure 2

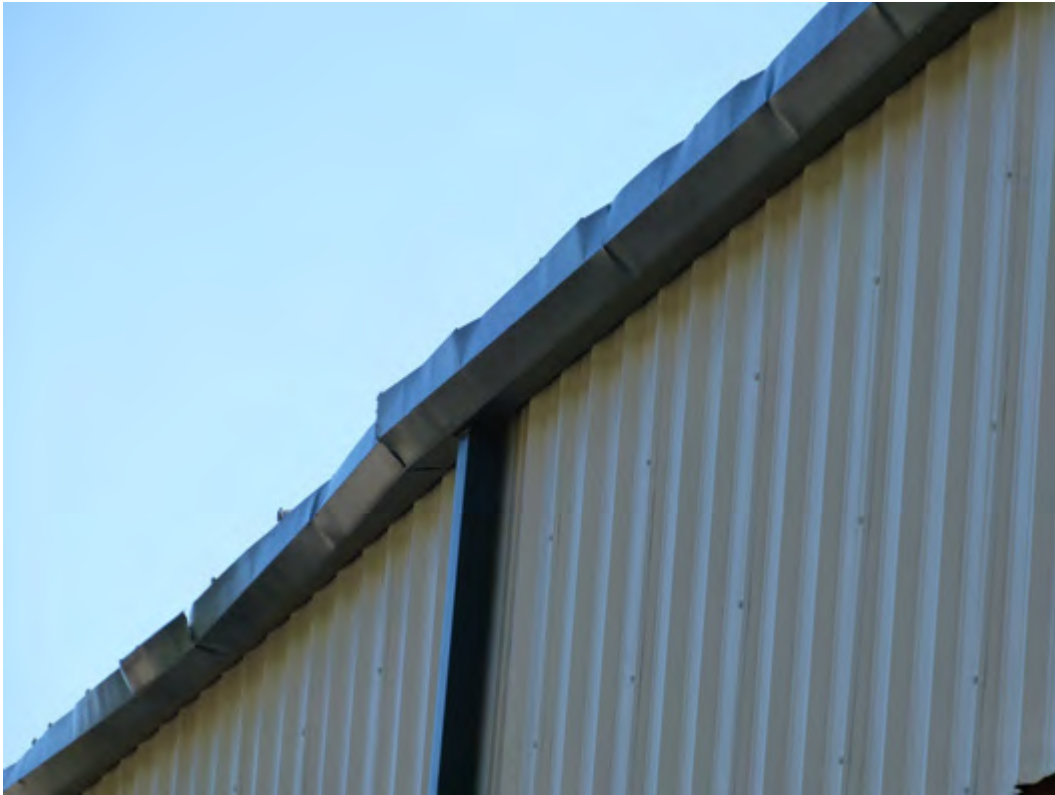
Figure 5 – Close-up view of damaged gutter in Figure 2

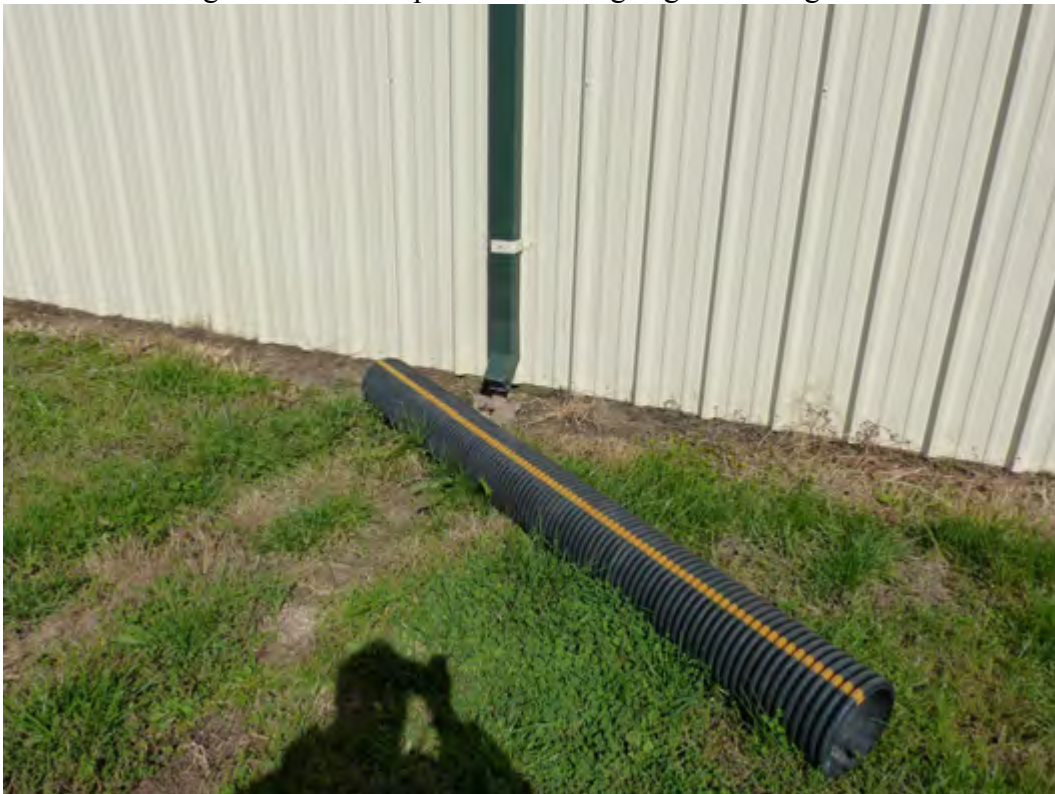
Figure 6 – Downspout discharges next to foundation, South side of Building D

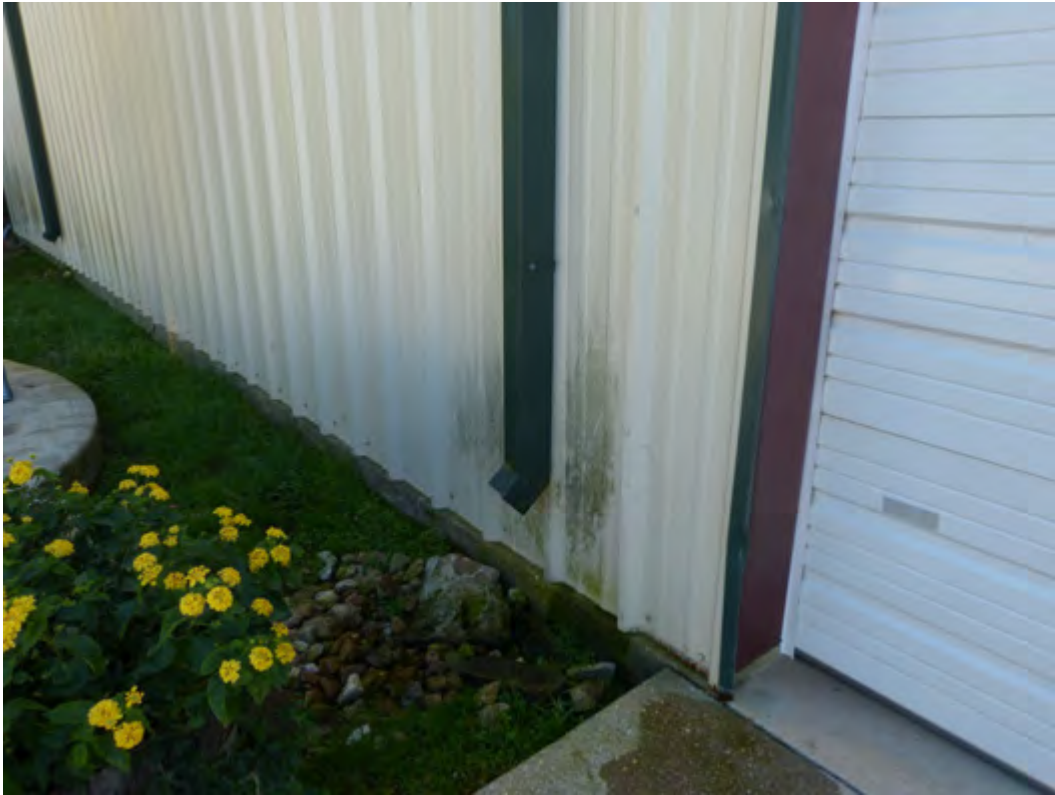
Figure 7 – Downspout discharges next to foundation, North side of Building B

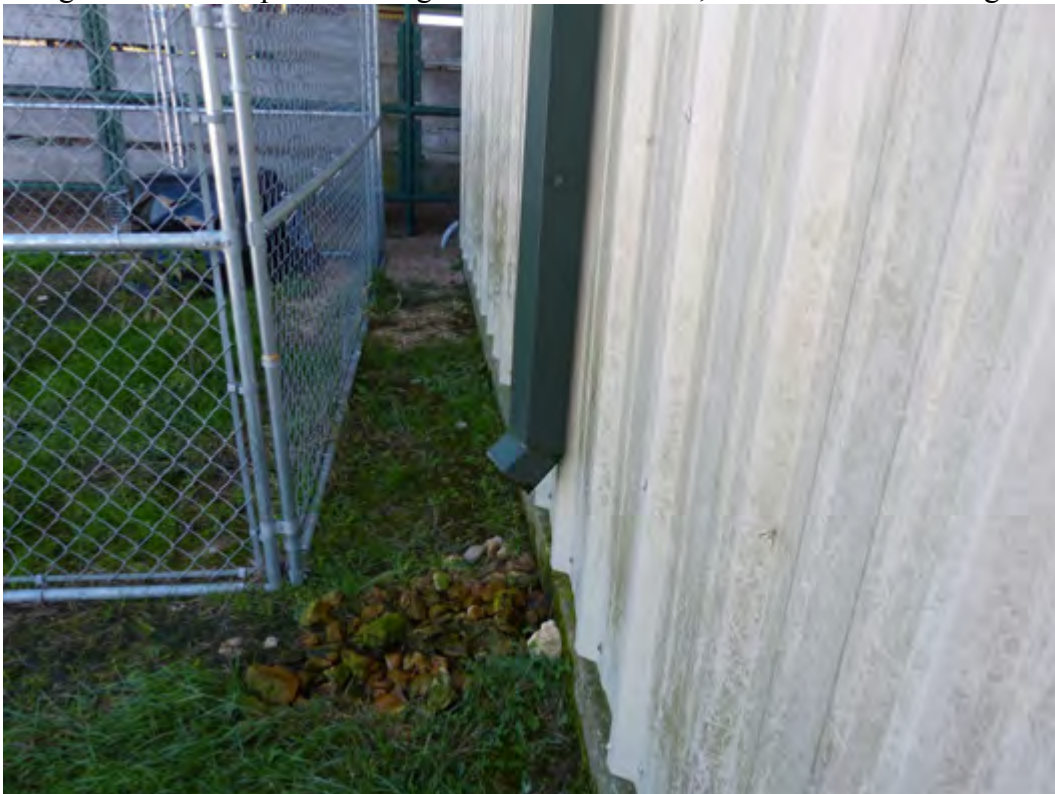
Figure 8 – Downspout discharges next to foundation, North side of Building B

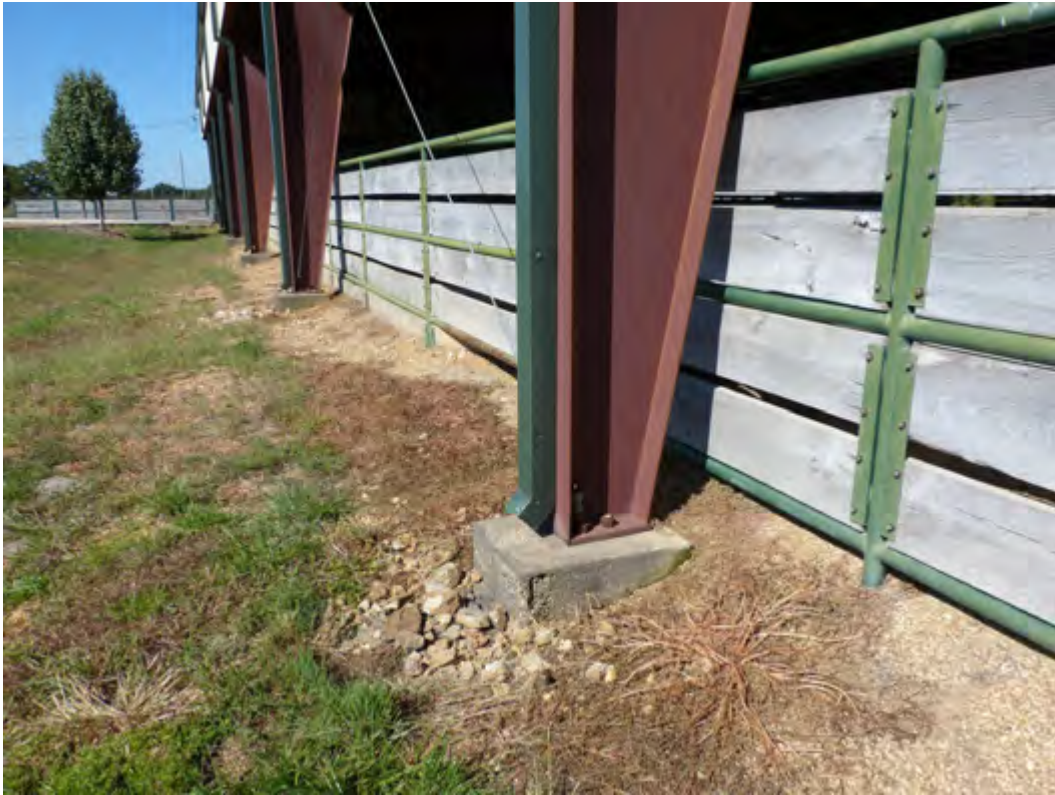
Figure 9 – Footing at girder G6R, Building C, South side.

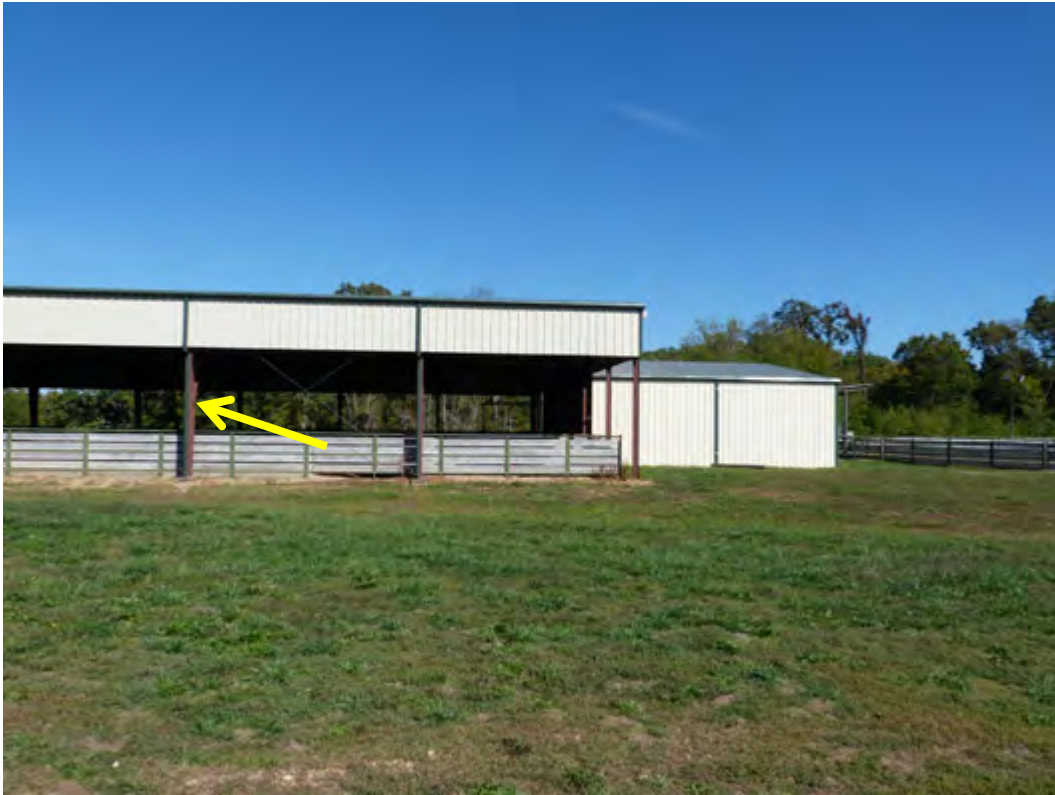
Figure 15 – Damaged G5R girder location, Building C, South side.

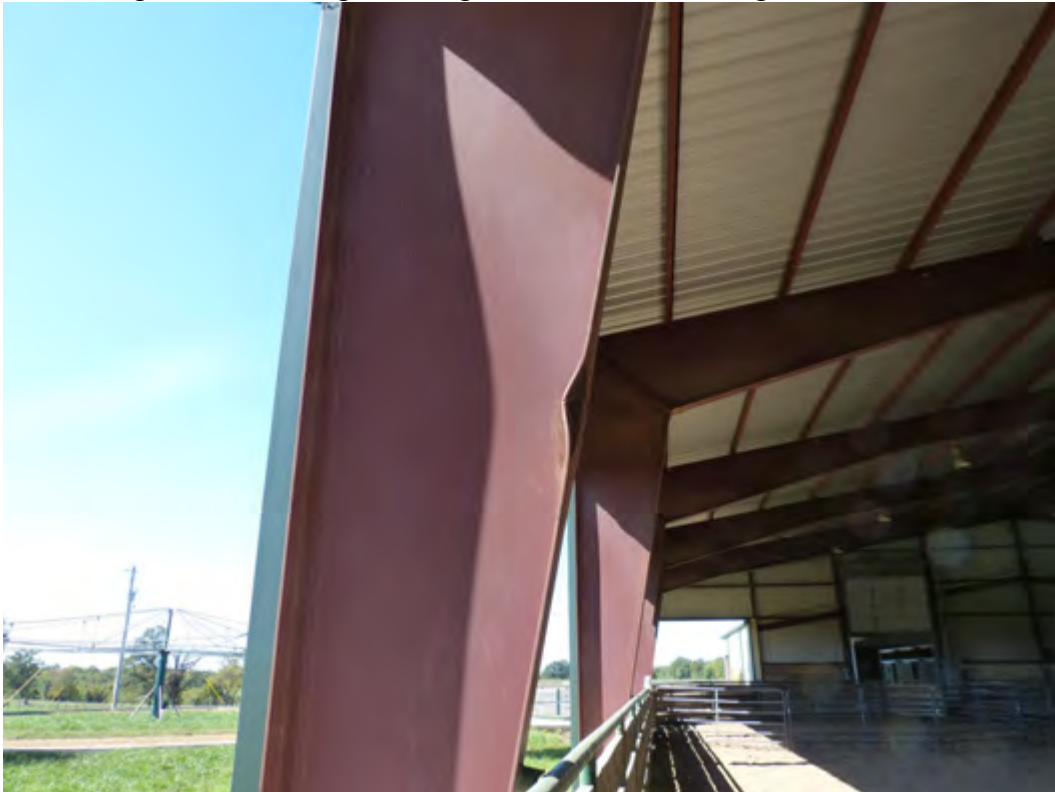
Figure 16 – Damaged G5R girder, Building C, side view.

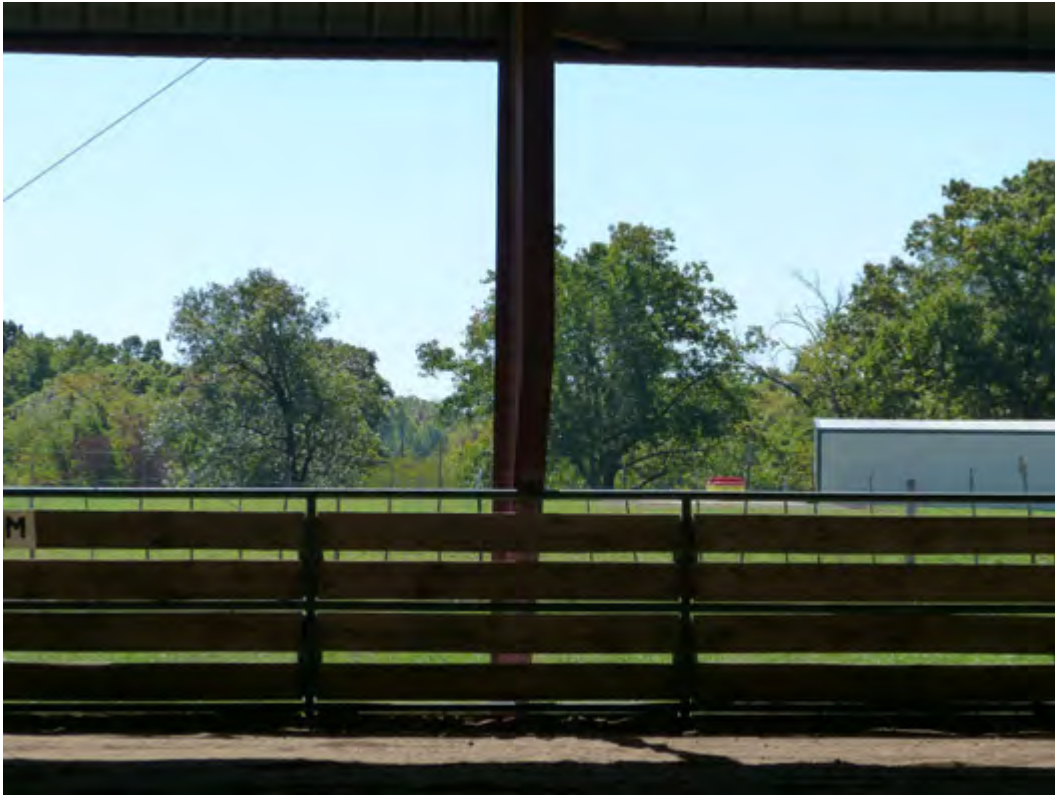
Figure 17 – Damaged G5R girder, Building C, inside view.

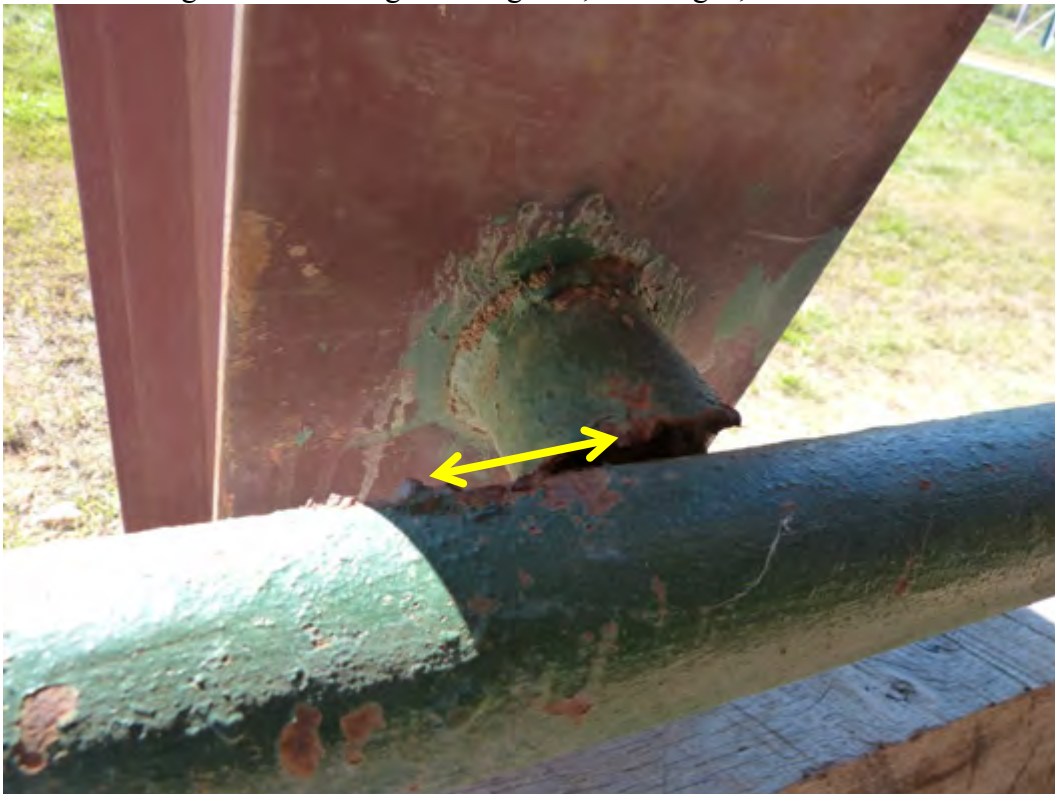
Figure 18 – Damaged G5R girder, Building C, sideways displacement.

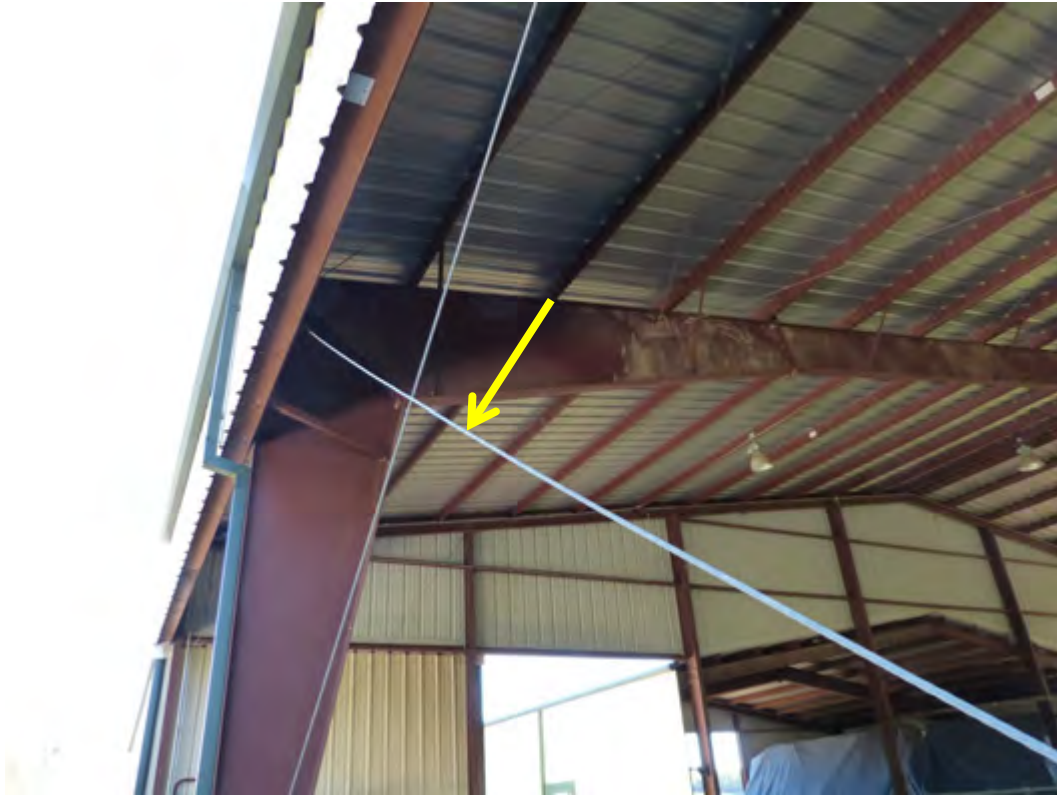
Figure 19 – Loose sidewall cable bracing, Building C, North side.

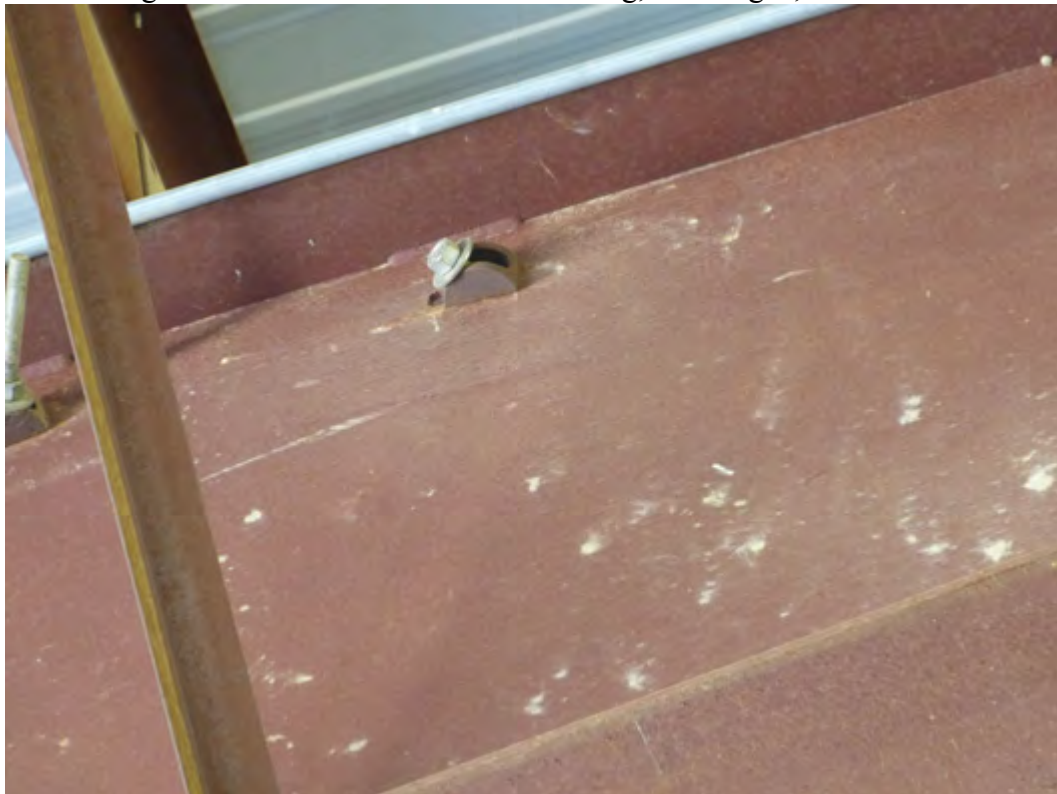
Figure 20 – Roof cable bracing eye-bolt nut

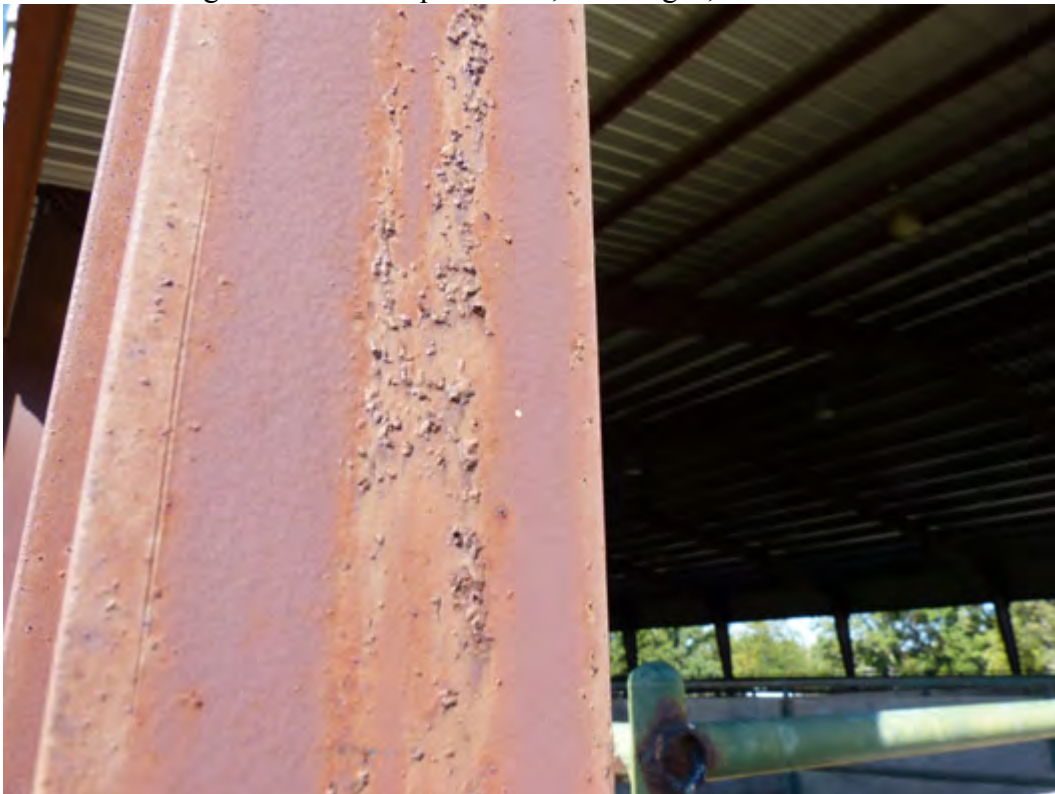
Figure 24 – Surface rust on exposed structural steel.

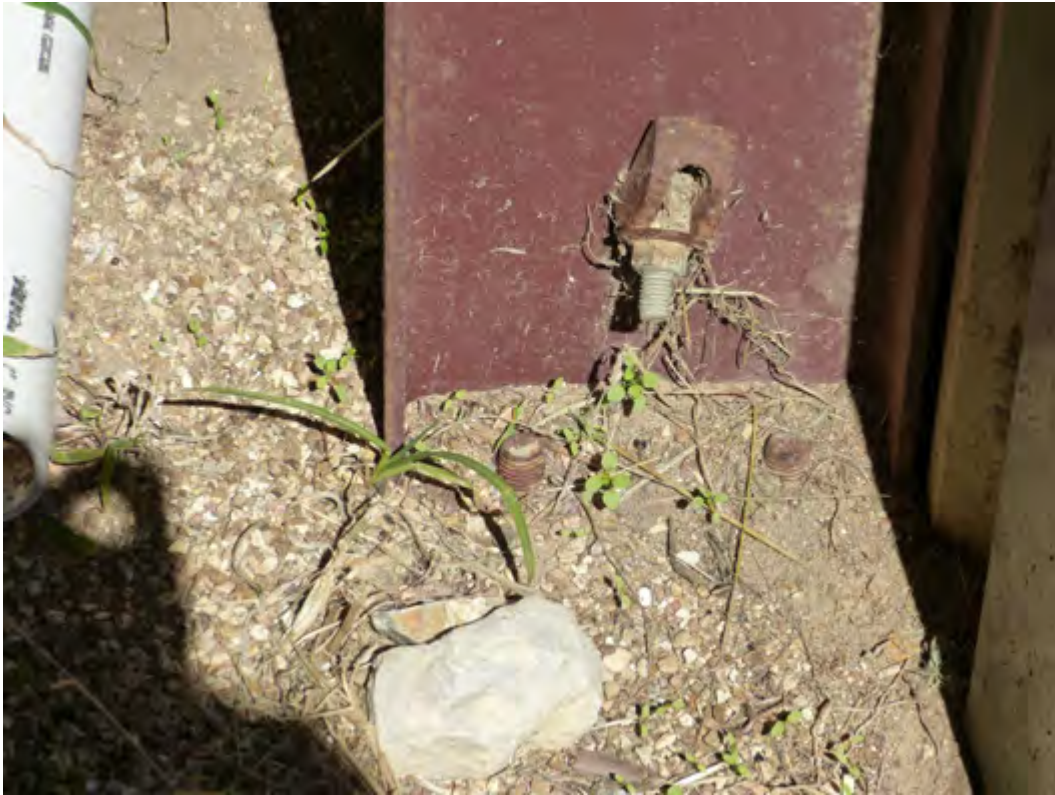
Figure 25 – Column base plate covered with soil.

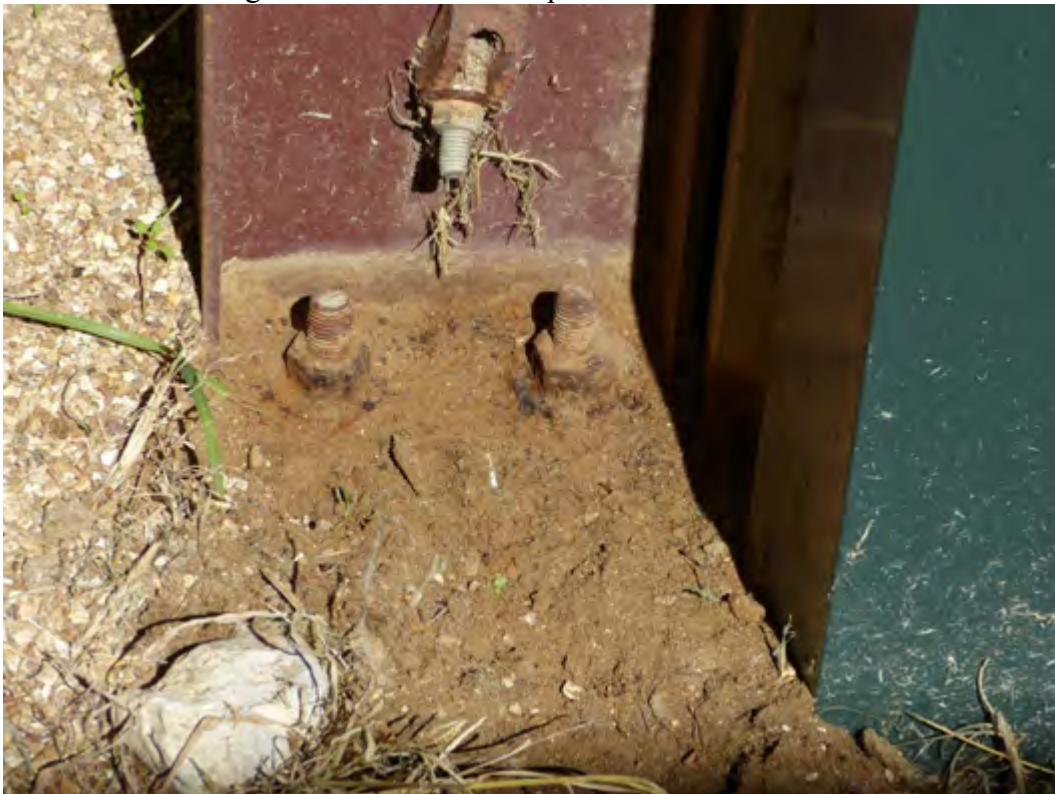
Figure 26 – Rusty bolts in Figure 25 exposed.

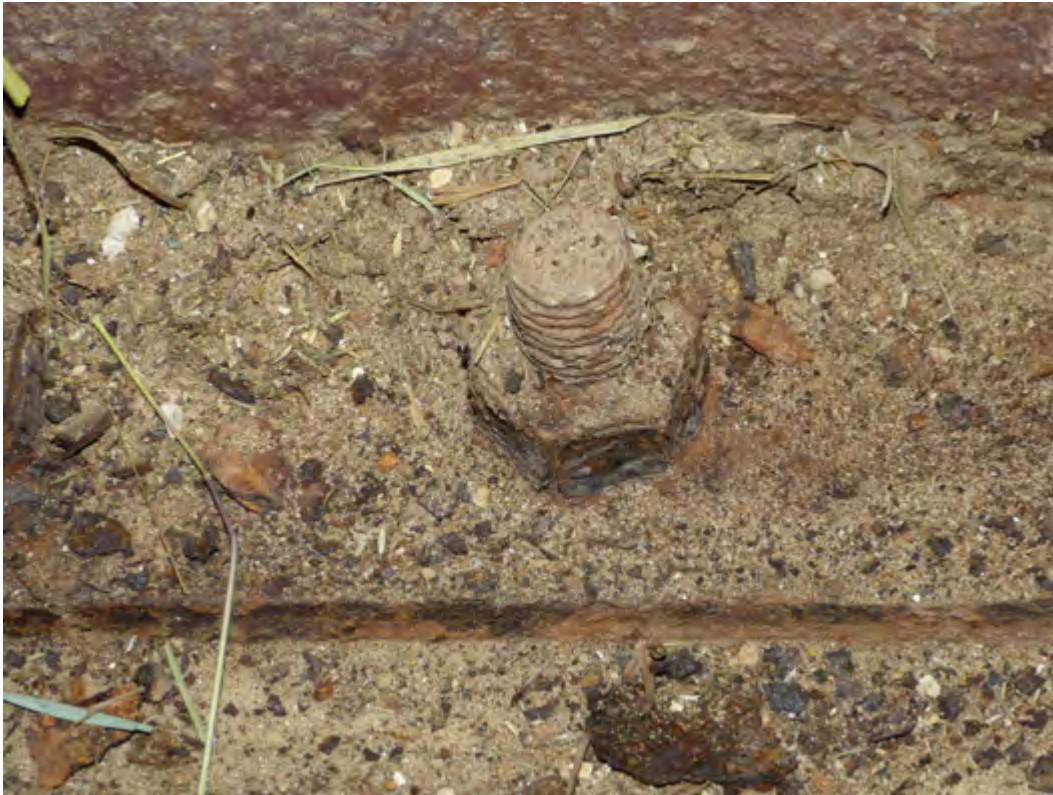
Figure 27 – Rusted bolts and section loss at column base plate.

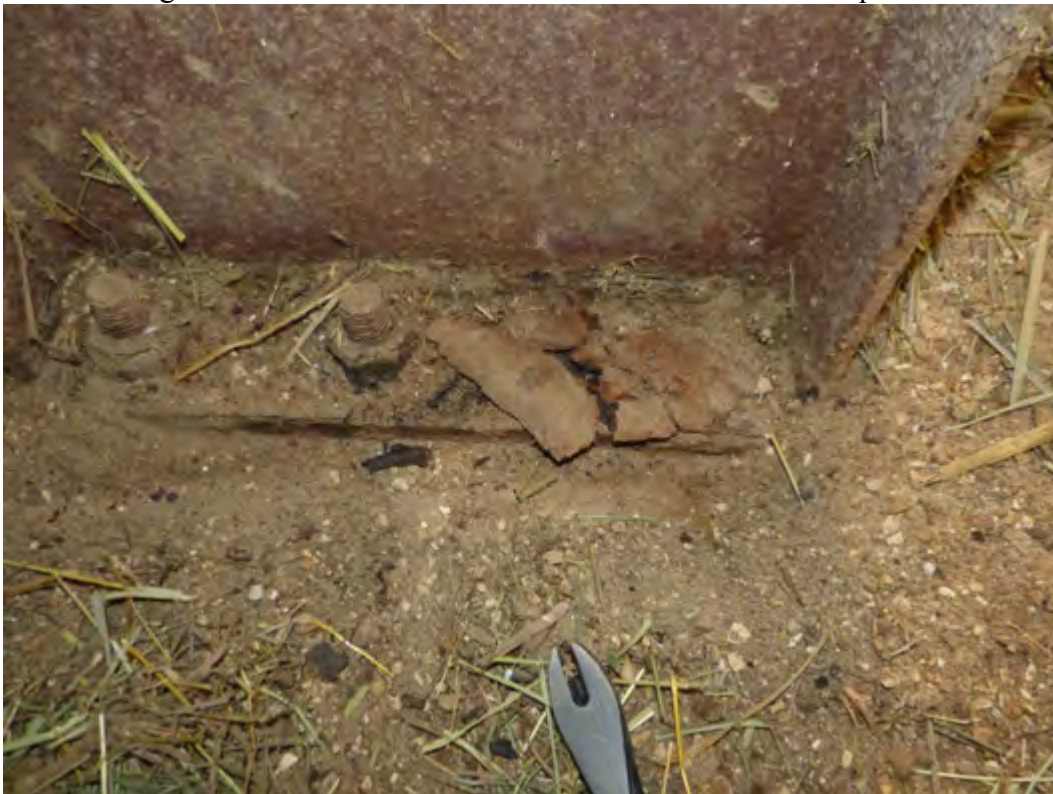
Figure 28 – Rusted bolts and section loss at column base plate.
